Subject: Annual Inspection Report
South Alabama Regional Airport

ANNUAL INSPECTION REPORT

SOUTH ALABAMA REGIONAL AIRPORT

ANDALUSIA, ALABAMA

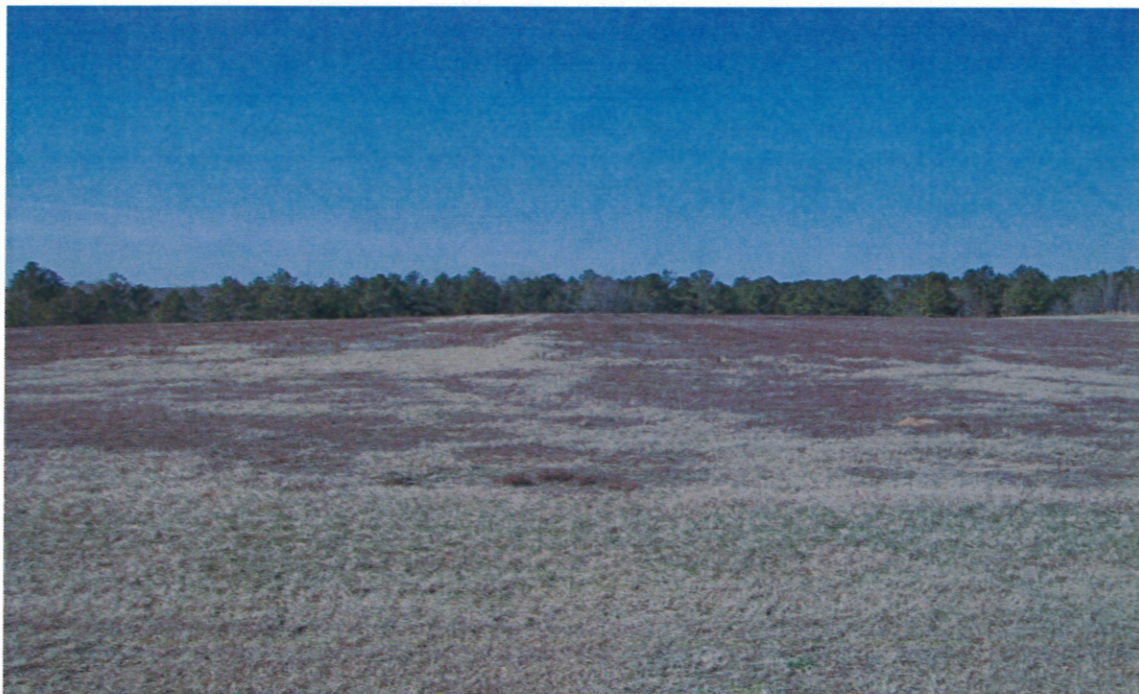
Photo # 1 –Runway 11

- Runway 11: No obstructions (Photo # 1)
- Runway 29: No obstructions (Photo # 2)

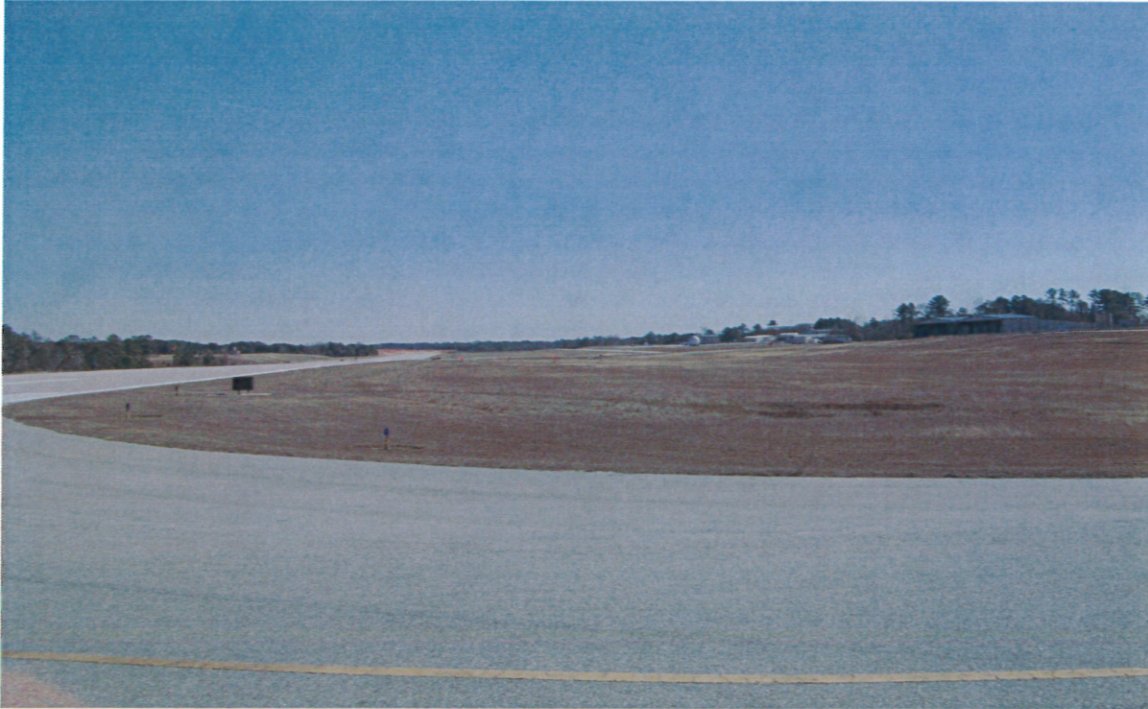
Photo # 3 – Primary Surface and Safety Area

- The primary surface meets state requirements (Photo # 3).

- The grade of the runway safety area meets state requirements (Photo # 3).

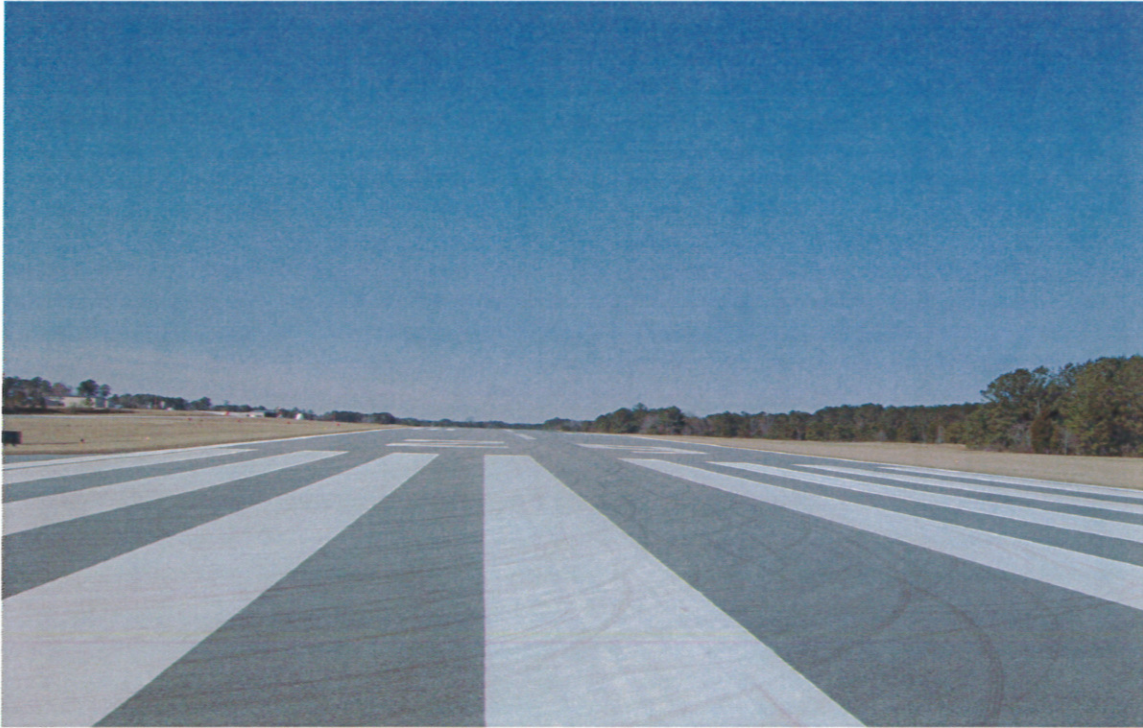
Photo # 4 – Non-Precision Instrument Approach Markings

- All airport markings and signage are in good condition (Photo # 4).

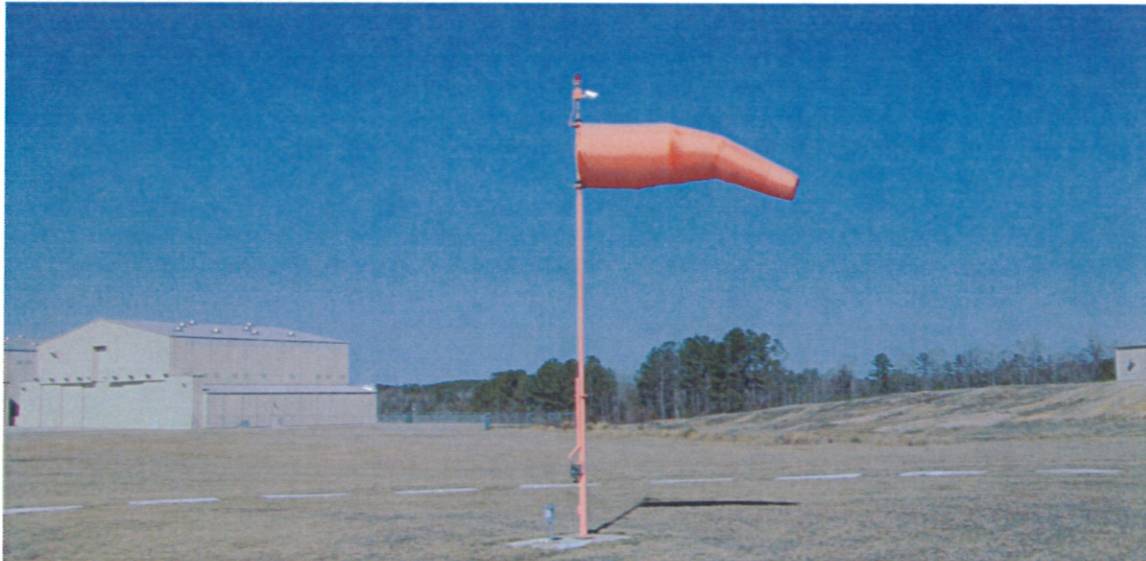
Photo # 5 – Wind Cone

- The wind direction indicator (wind cone) is operational and in good condition (Photo # 5).

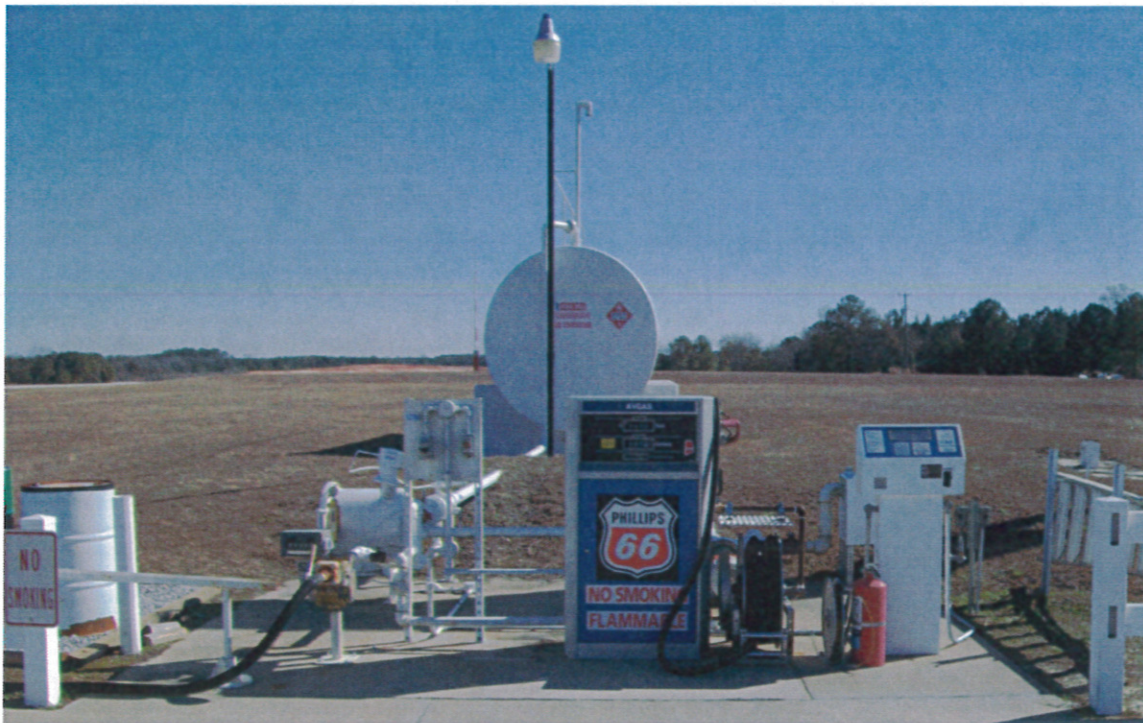
Photo # 6 – Avgas Self Service Facility

- The fueling area meets the requirements established by the Alabama Department of Transportation. However, the State of Alabama Department of Agriculture and Industries may have additional requirements for fueling systems that were not considered during this inspection (Photo # 6).
